## **Suggestions to Modify NSI Cooling System**

### **By Rupert Clarke**

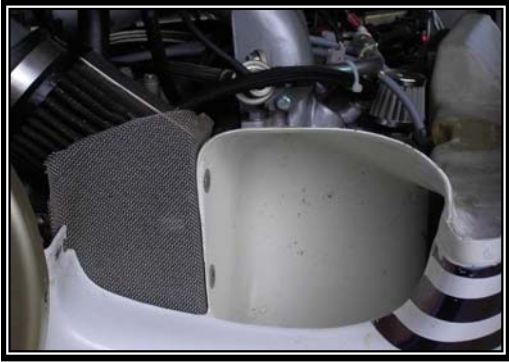
# 1 STAINLESS STEEL SCREEN FROM FRONT

- Stainless steel screens to reduce and smooth *over engine* airflow - **Photos #1, 2 & 3.**
- Rounded internal fairings in radiator ducts to smooth airflow - **Photos # 4 & 5**
- Reflective heat insulation under muffler (we had to replace the bottom of the cowl) **Photo #6**
- Additional cut out at rear of lower cowl (may not be necessary) **Photo #6**
- Rounded fairing at bottom of firewall - **Photos #7 & 8**
- Added SS tube T piece to flow both heater and throttle body coolant to thermostat housing **Photo #8**
- Radiator fans (may not be necessary) These fans are pretty heavy, 10 lbs, and are set to switch on at 200° so I am thinking of removing them. **Photo #9**
- Insulated the muffler and muffler inlet pipes **Photo #10**

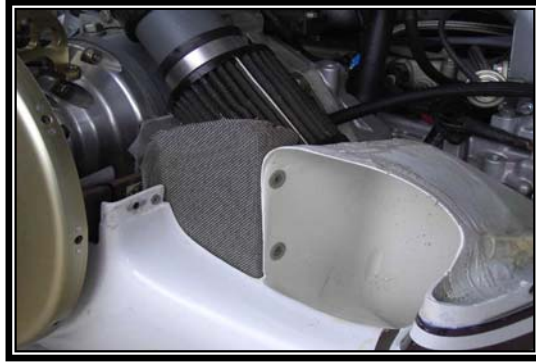
#2 STAINLESS STEEL SCREEN LEFT SIDE

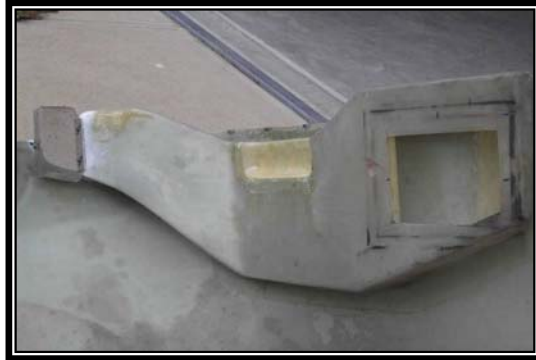
#4 COWL DUCT INTERIOR FAIRING

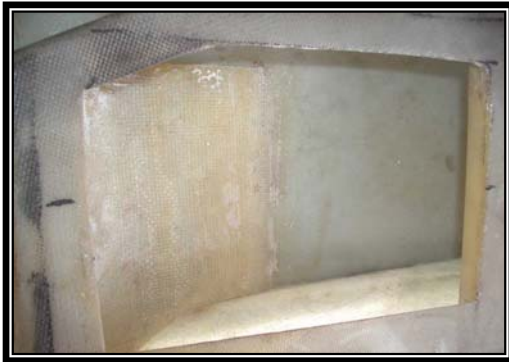
#5 DUCT FAIRING

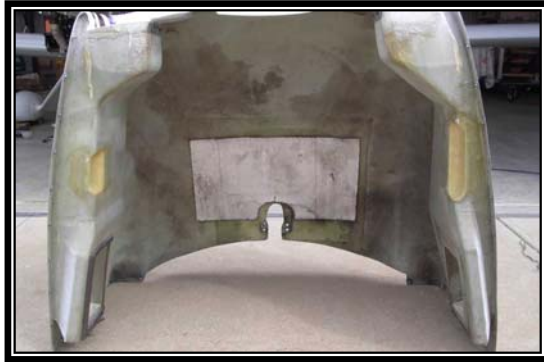
# 6 BOTTOM DEFLECTOR AND CUTOUT

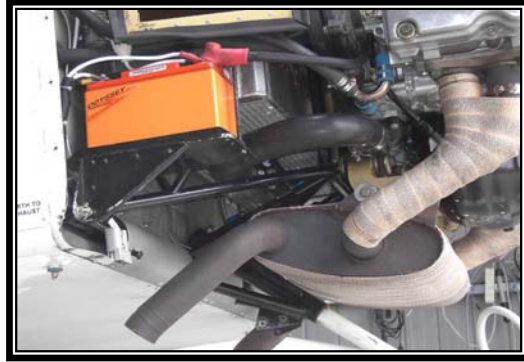
#8 FORWARD DEFLECTOR AND HOSE "T"

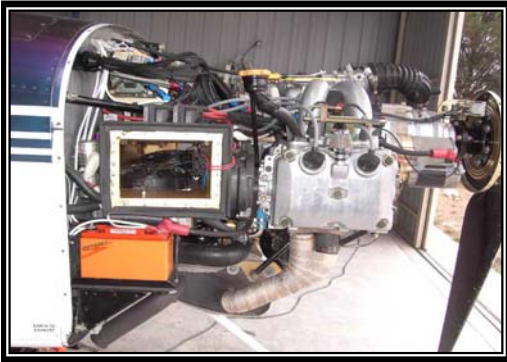
#9 COOLING DUCT FANS

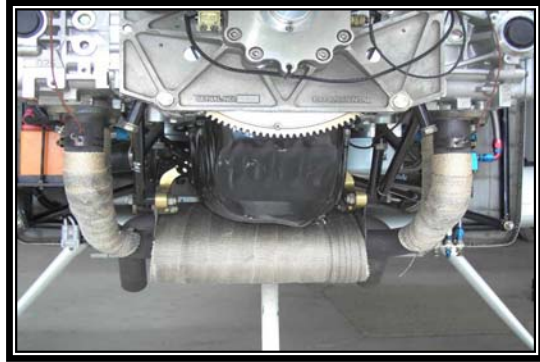
#10 MUFFLER WRAP
